# PROJECT COMPLETION REPORT

## 2004 Sonar AS Herbicide Treatment of Lake St. Catherine, Lily Pond and Little Lake

November 2004

Aquatic Control Technology, Inc.  
11 John Road  
Sutton, MA 01590-2509

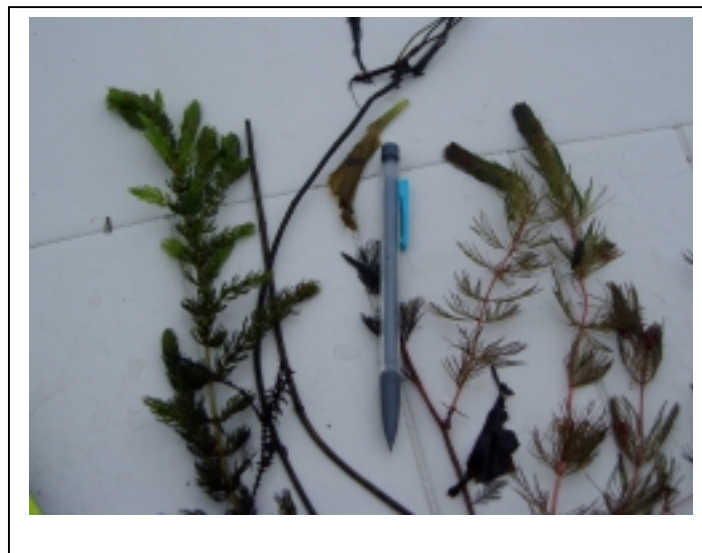
5/22/04 – coontail, largeleaf pondweed and Eurasian watermilfoil during pre-treatment inspection

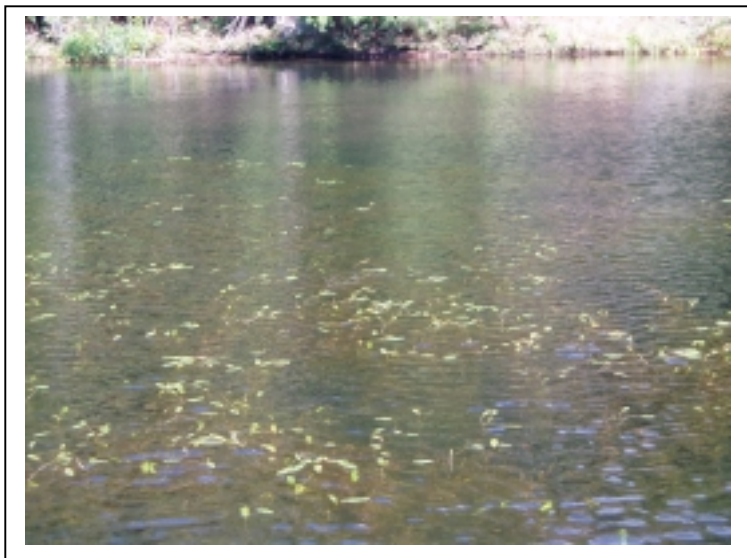
9/20/04 – floating-leaves of largeleaf pondweed in Lily Pond during post-treatment inspection

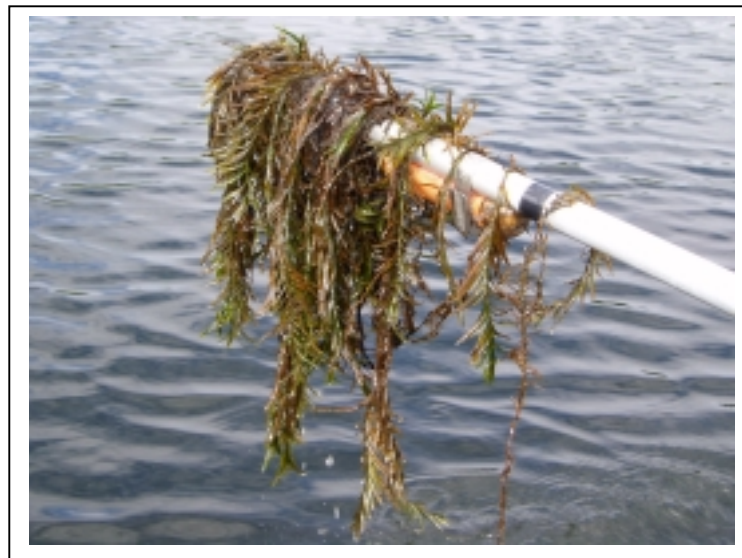
9/20/04 – Viable Robbins pondweed collected in Lake St. Catherine during post-treatment inspection
