**ANNUAL VEGETATION MONITORING REPORT**  
**2006 Aquatic Plant Surveys of**  
**Lake St. Catherine, Lily Pond and Little Lake**

November 2006

Aquatic Control Technology, Inc.  
11 John Road  
Sutton, MA 01590-2509

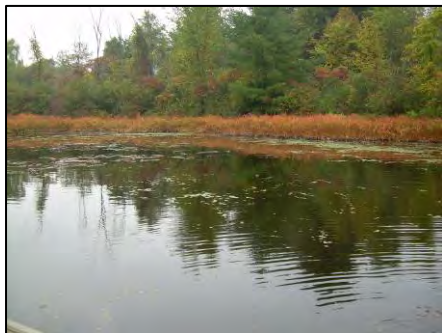
Lily Pond 9/19/06

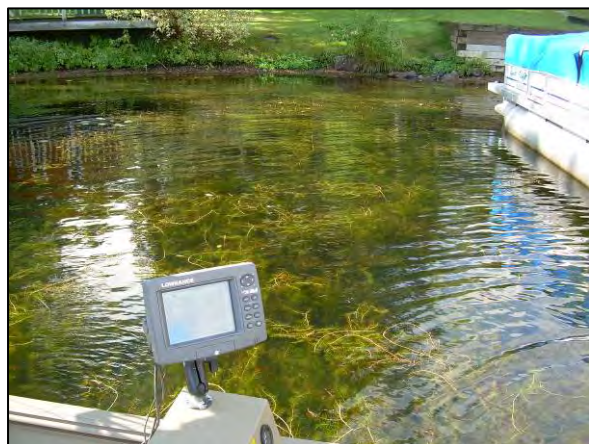
Eurasian watermilfoil in Cold Spring Bay 9/20/06

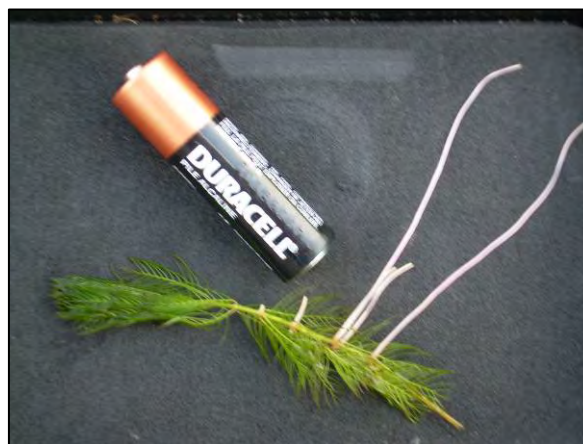
Floating Eurasian watermilfoil fragments with adventitious roots seen at southern end of Lake St. Catherine 9/20/06

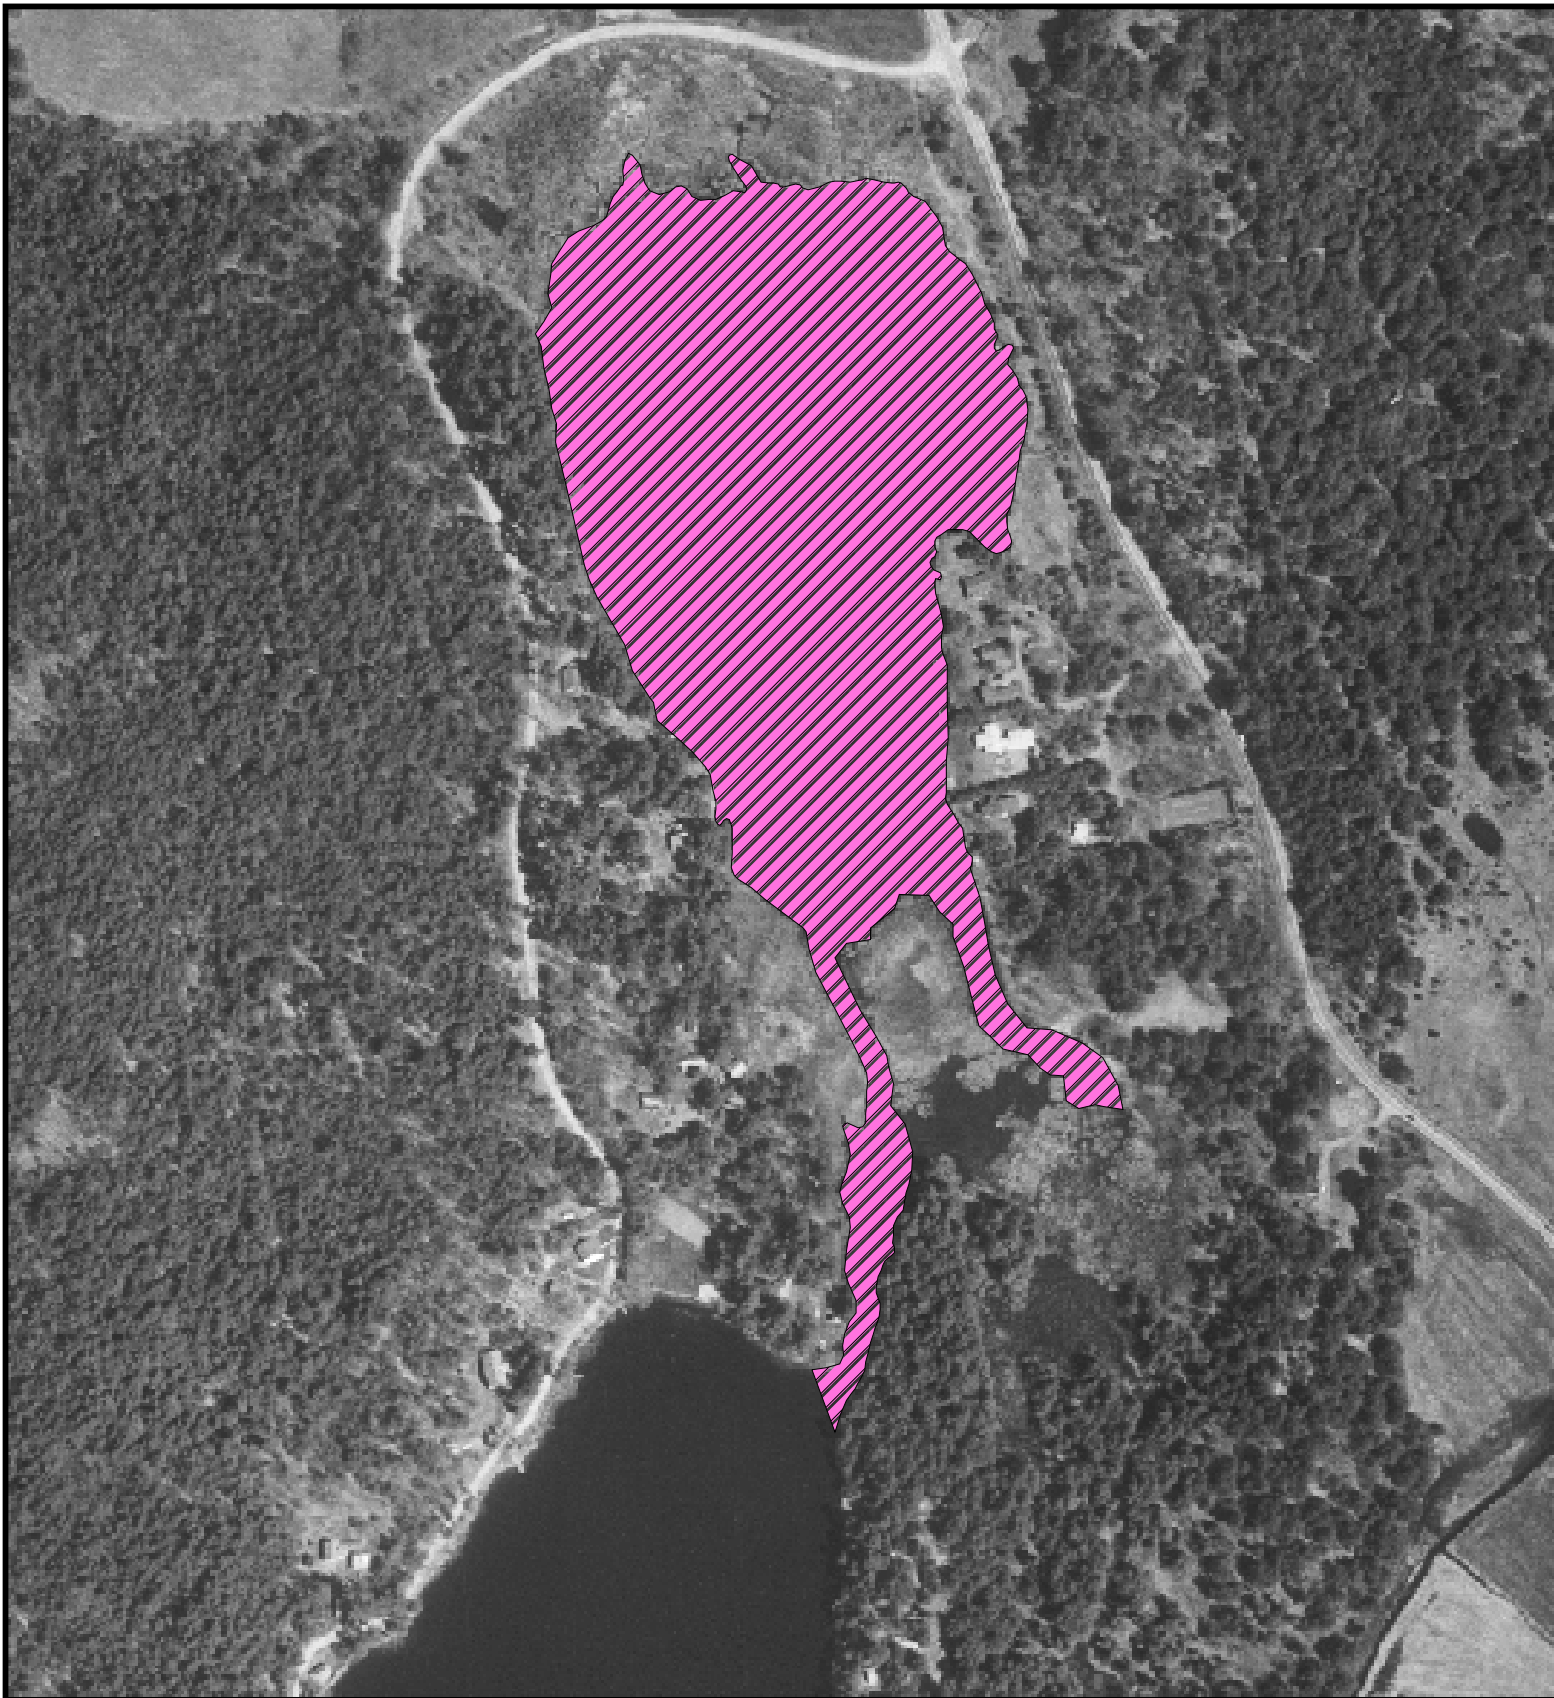
FIGURE:	TREATMENT DATE:	MAP DATE:
4	6/21/06	11/2/06

Poultney & Wells, VT  
2006 Lily Pond Treatment Map

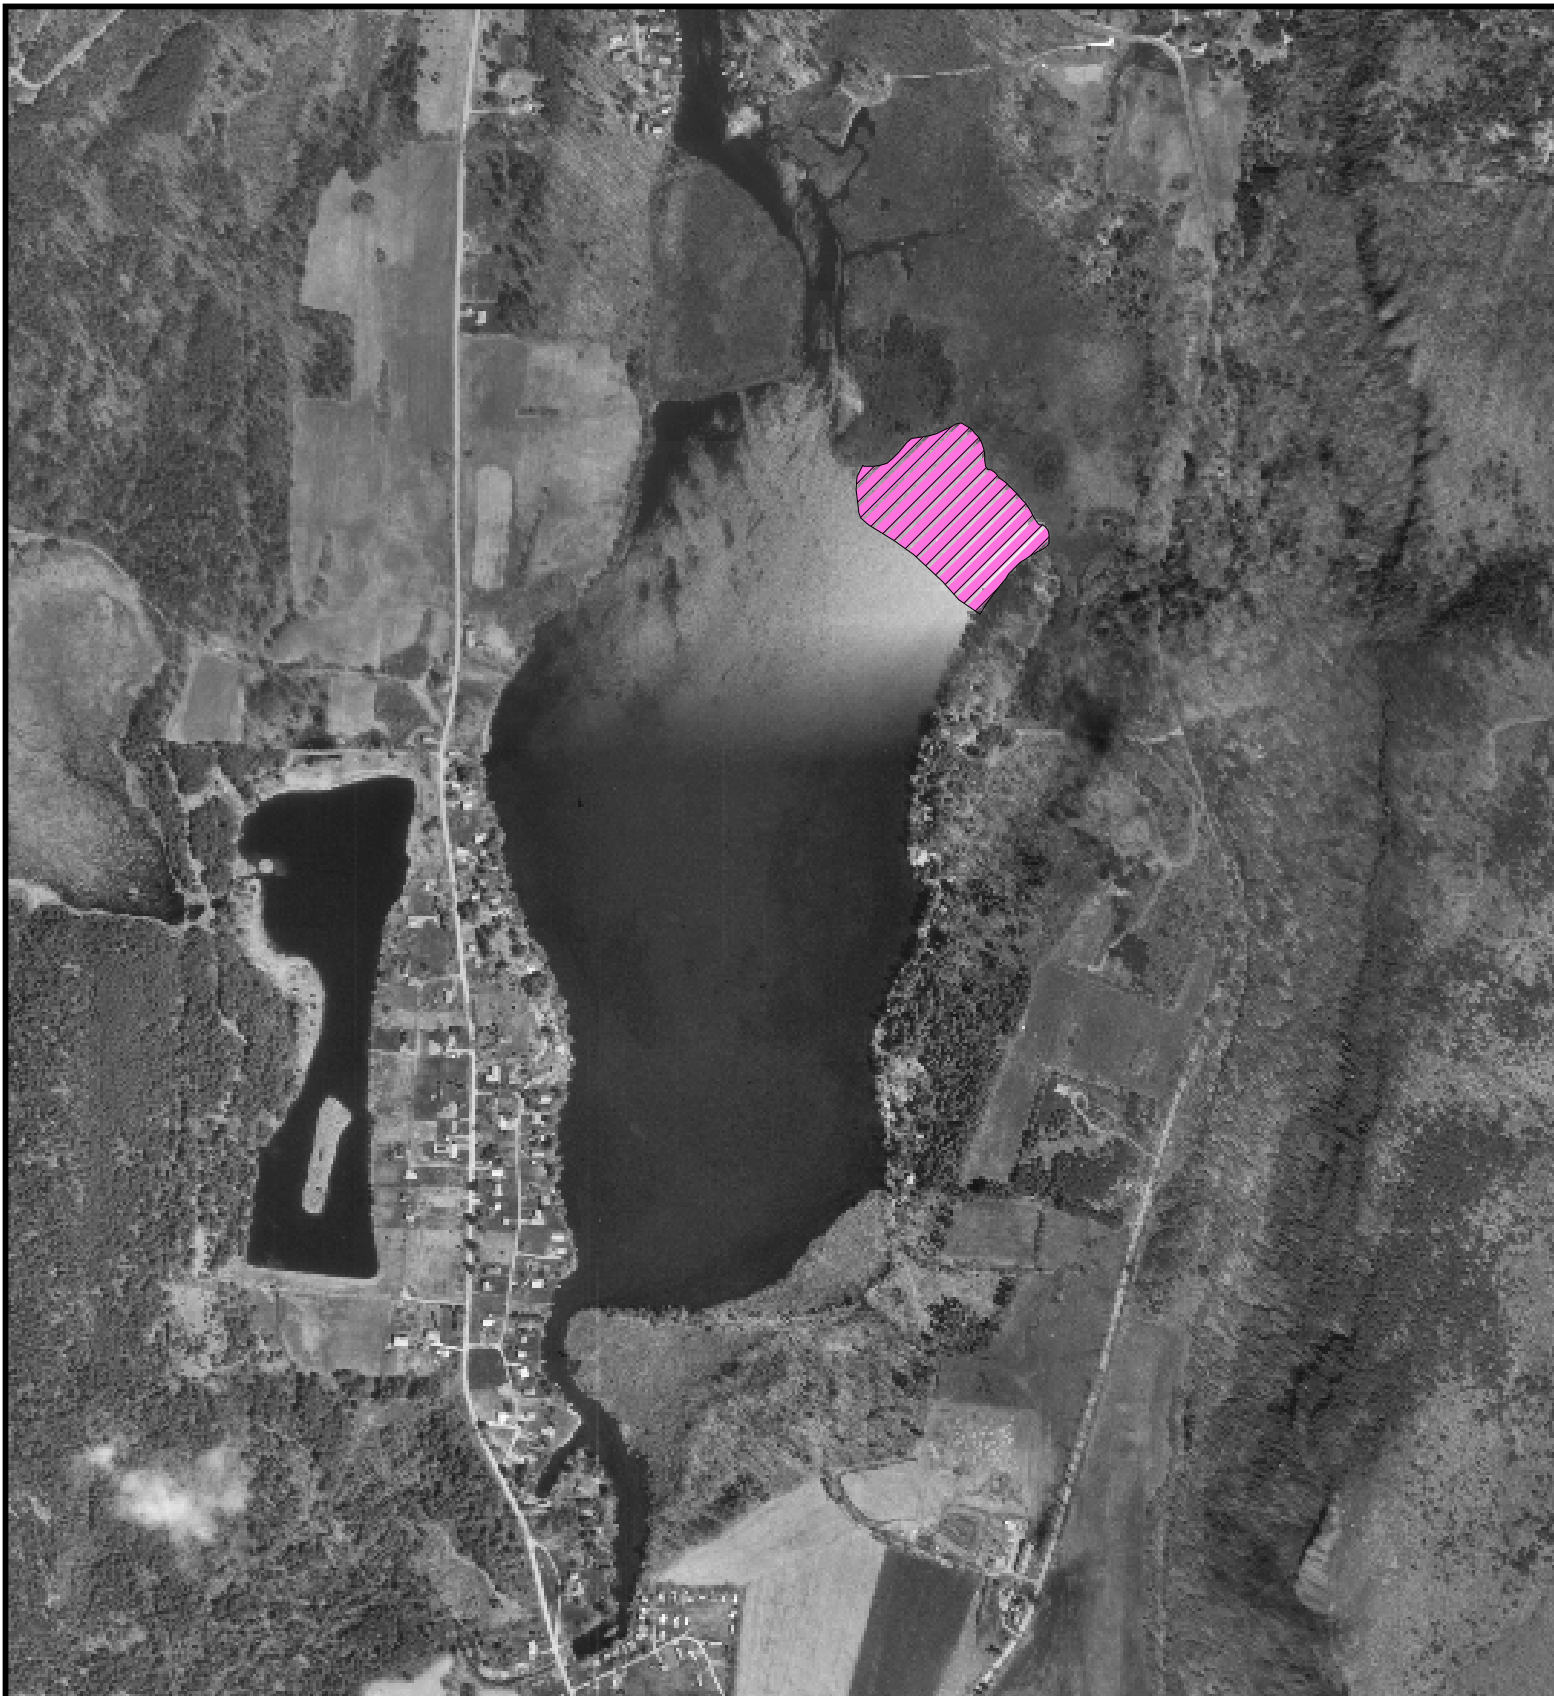
FIGURE:	TREATMENT DATE:	MAP DATE:
5	6/21/06	11/2/06

Poultney & Wells, VT  
2006 Little Lake Treatment Map
