Lake St. Catherine

Aquatic Vegetation Management Program 2007 – Year Four Report

Final Version: December 2007

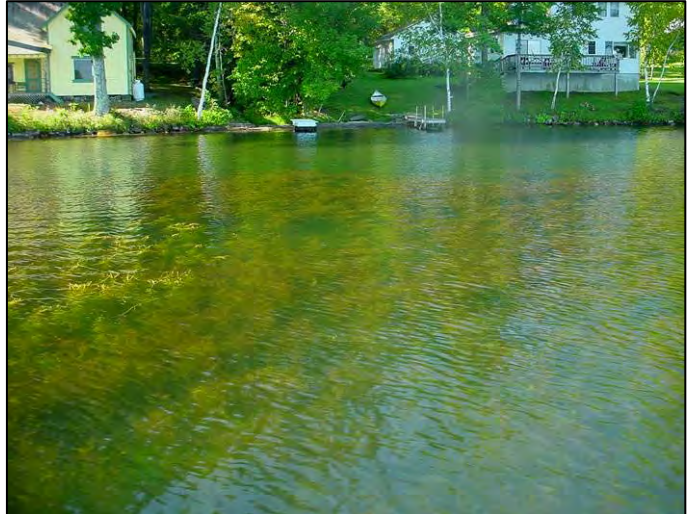
Bed of Eurasian watermilfoil and pondweed

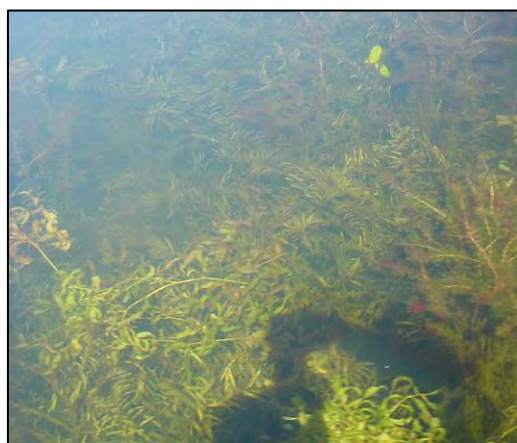
Abundant growth of pondweed with scattered milfoil – Little Lake (9/18/07)

Consistent with the other two basins, milfoil was widely distributed throughout Little Lake at low densities. Areas with higher density milfoil growth (>10% cover) were limited to fairly small patches. Where milfoil densities were less than 5%, plants were often difficult to see due to the abundant pondweed growth.

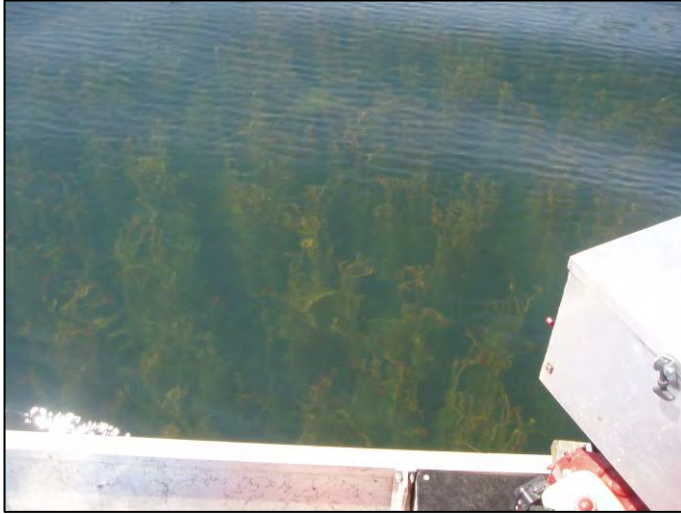
Top Left: Milfoil approaching the surface in Forest House Bay treatment area (7/17/07)

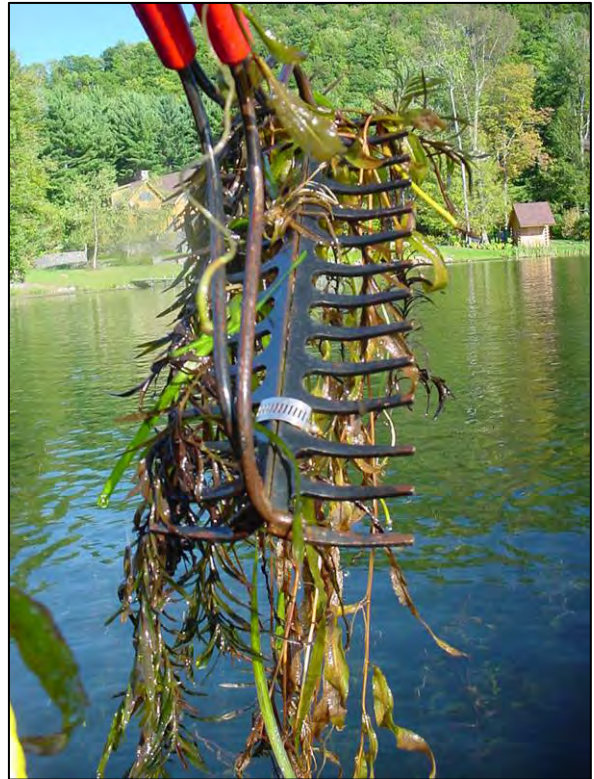
Top Right: Mixed native plants collected in Cold Spring Bay treatment area (9/17/07)

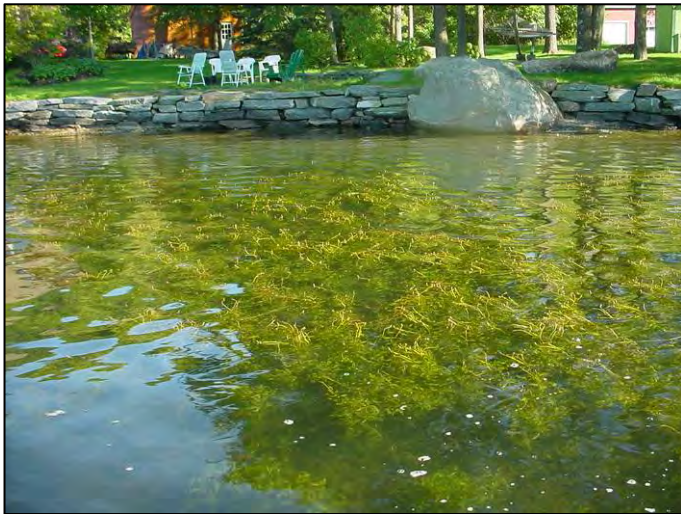
Bottom Left: Pondweed growth breaking the surface in Cold Spring Bay treatment area (9/17/07)

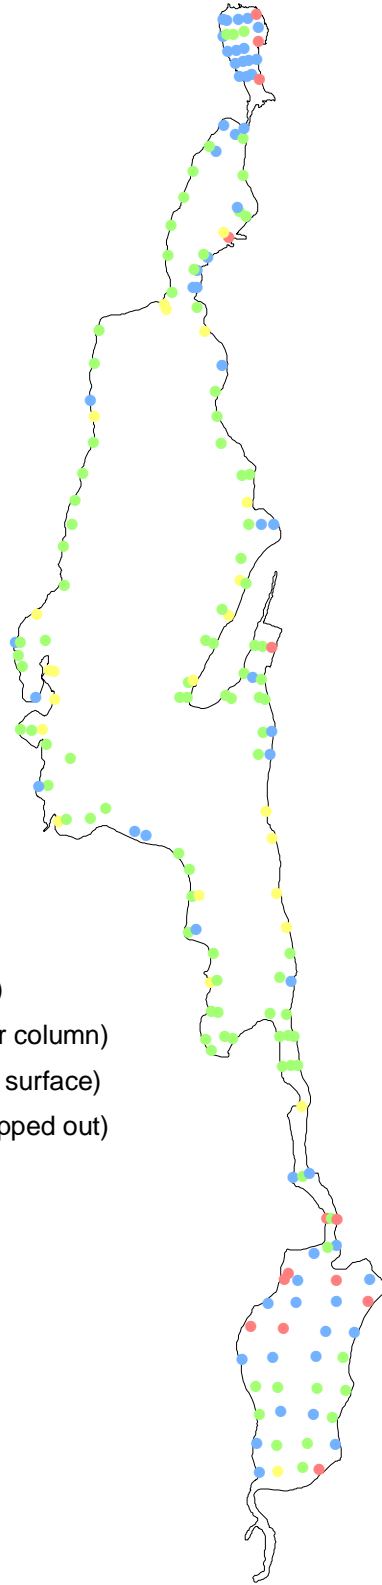
2007 TOTAL VEGETATION BIOMASS

Biomass indices reported
during 9/17/07 and 9/18/07 survey
