# Lake St. Catherine

## Aquatic Vegetation Management Program 2009 - Year Six Report

**Draft Version: November 2009**

**Aquatic Control Technology, Inc.  
11 John Road  
Sutton, MA 01590**

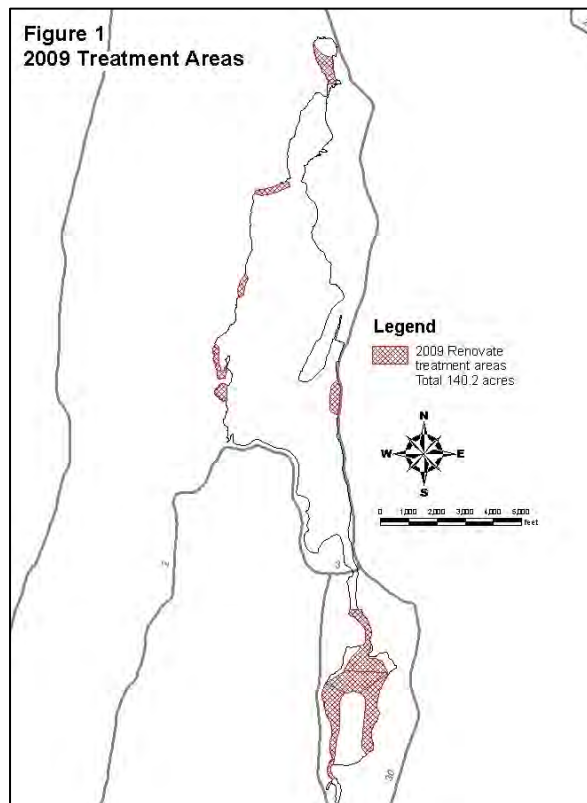
Final treatment areas (Figure 1) were located along the western shoreline and in both Lily Pond and Little Lake; only one area along the eastern shore was targeted for treatment. The final treatment scope included 7 treatment areas ranging from 3.5 acres to 101 acres. In total, approximately 140 acres were targeted for treatment. Based on the morphology of treatment areas both liquid Renovate 3 and granular Renovate OTF were selected for use in 2009. Renovate 3 liquid was applied in both Lily Pond and Little Lake. The herbicide was applied at 0.75 ppm calculated on the entire water column. Renovate OTF granular was used in the more exposed areas in Lake St. Catherine to minimize dilution and maximize herbicide contact time in these areas. Renovate OTF was applied at 2.25 ppm based on the bottom four feet of the water column.

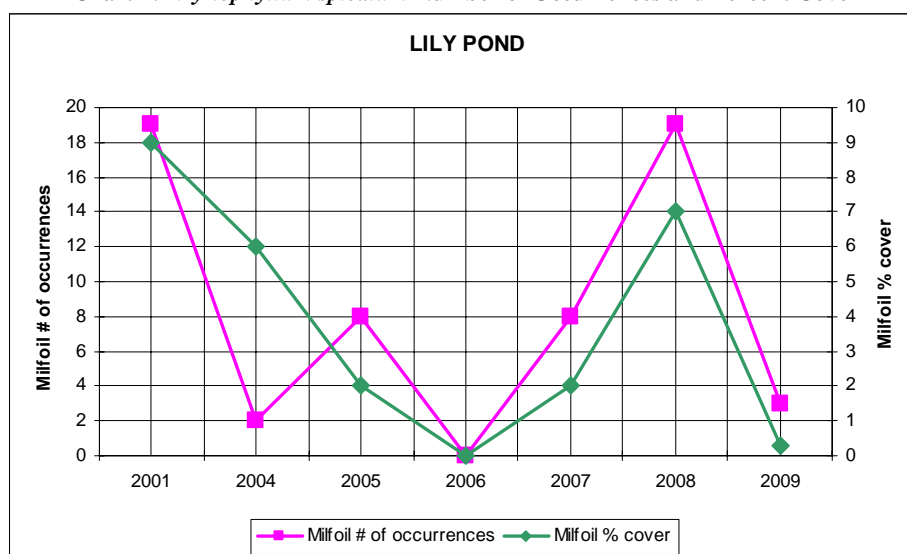
**Chart 1: *Myriophyllum spicatum* Number of Occurrences and Percent Cover**

Milfoil frequency and cover was reduced throughout Lily Pond being encountered at only 3 of the 24 (12.5%) data point locations. Milfoil cover where found was very low generally consisting of only a few widely scattered plants.

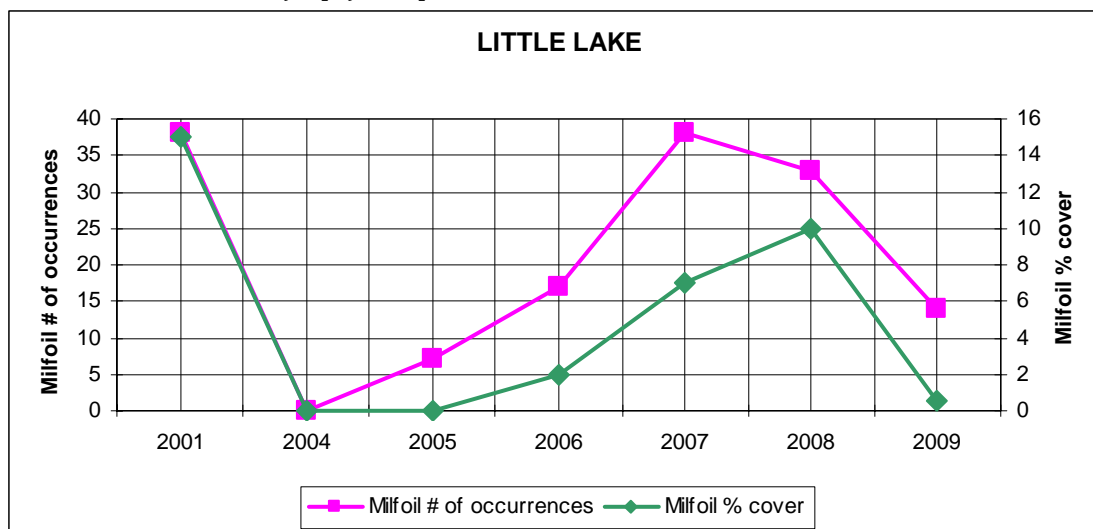
Chart 3: *Myriophyllum spicatum* Number of Occurrences and Percent Cover

Although treated with Renovate 3 some low density milfoil growth remained in Little Lake following treatment. Where encountered milfoil growth was immature and low growing, generally consisting of one or a few scattered plants. Though somewhat widespread, cover of milfoil in the basin was very low (<1%).

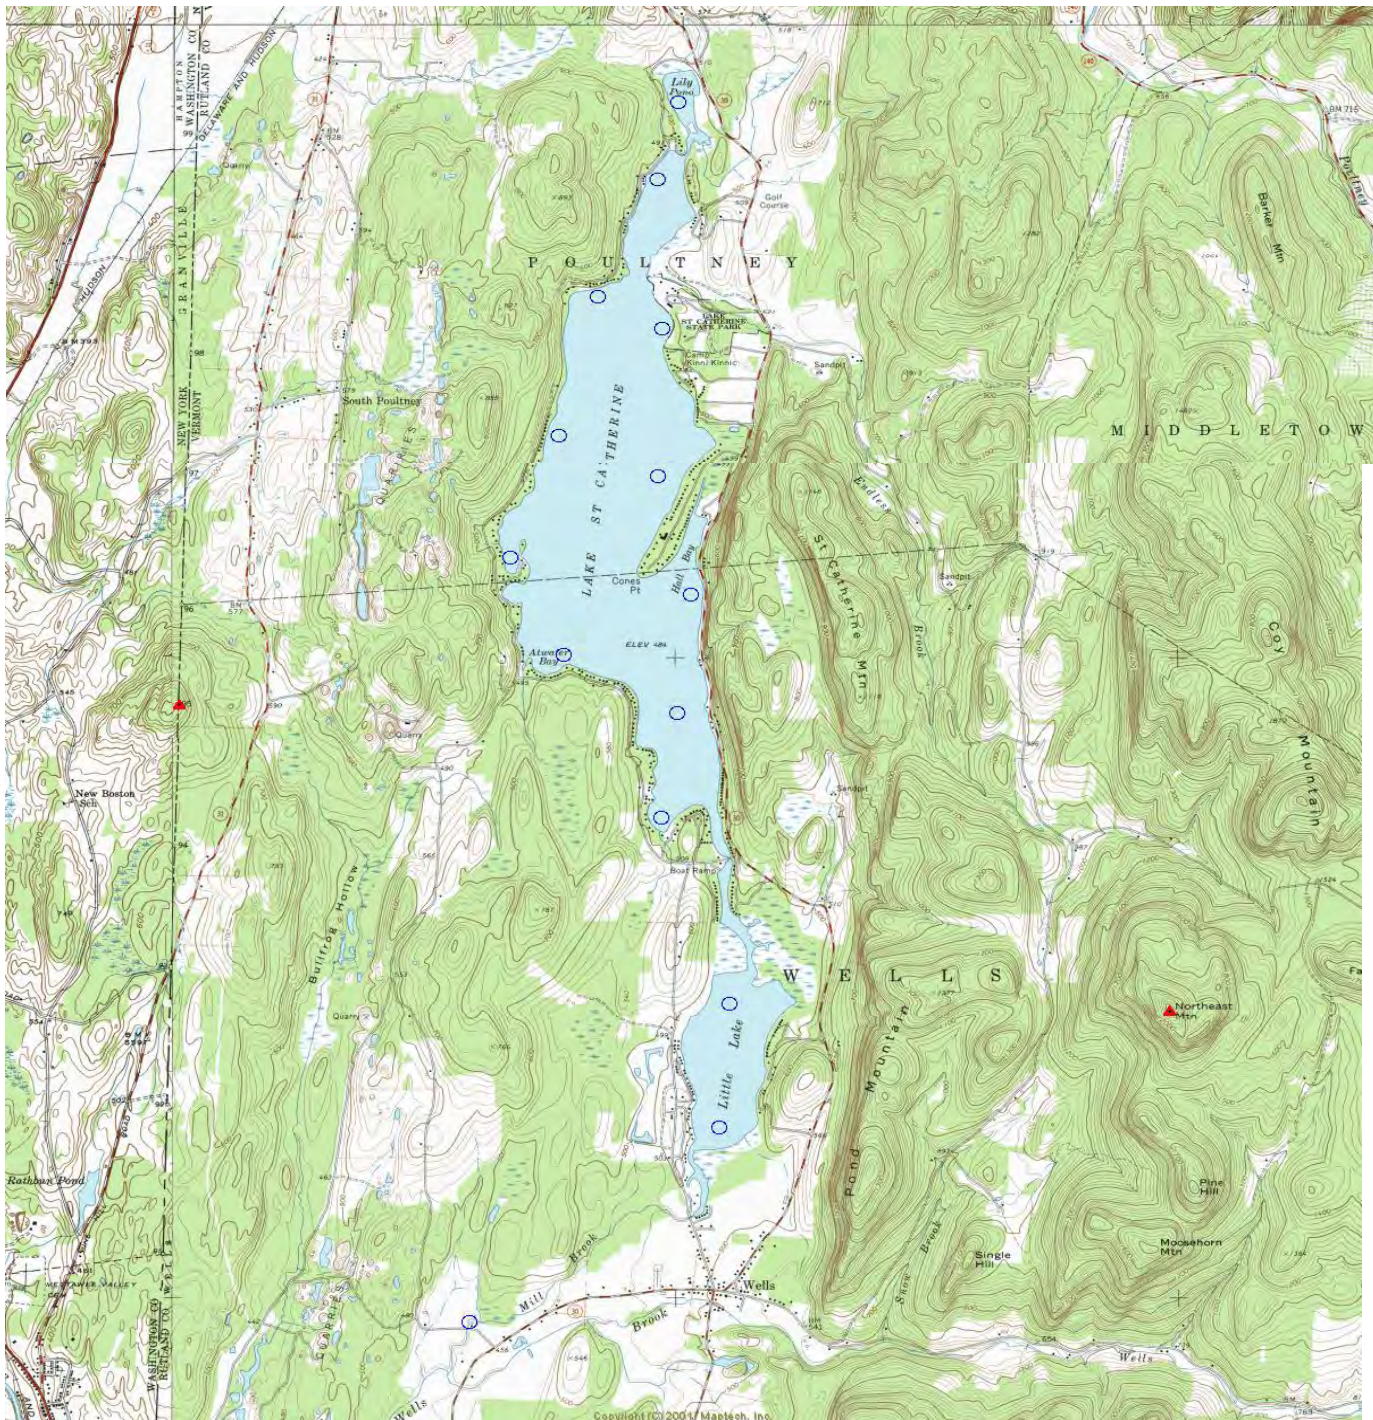
Page 45 of 49  
Attachment D - Sampling Site Locations (to be updated as needed)  
Specific Sampling Locations for 2009

O denotes 14 Sample Sites (note sample site where Mill Brook/Geer Rd. intersect)
