Lake St. Catherine

Aquatic Vegetation Management Program 2011 - Year Eight Report

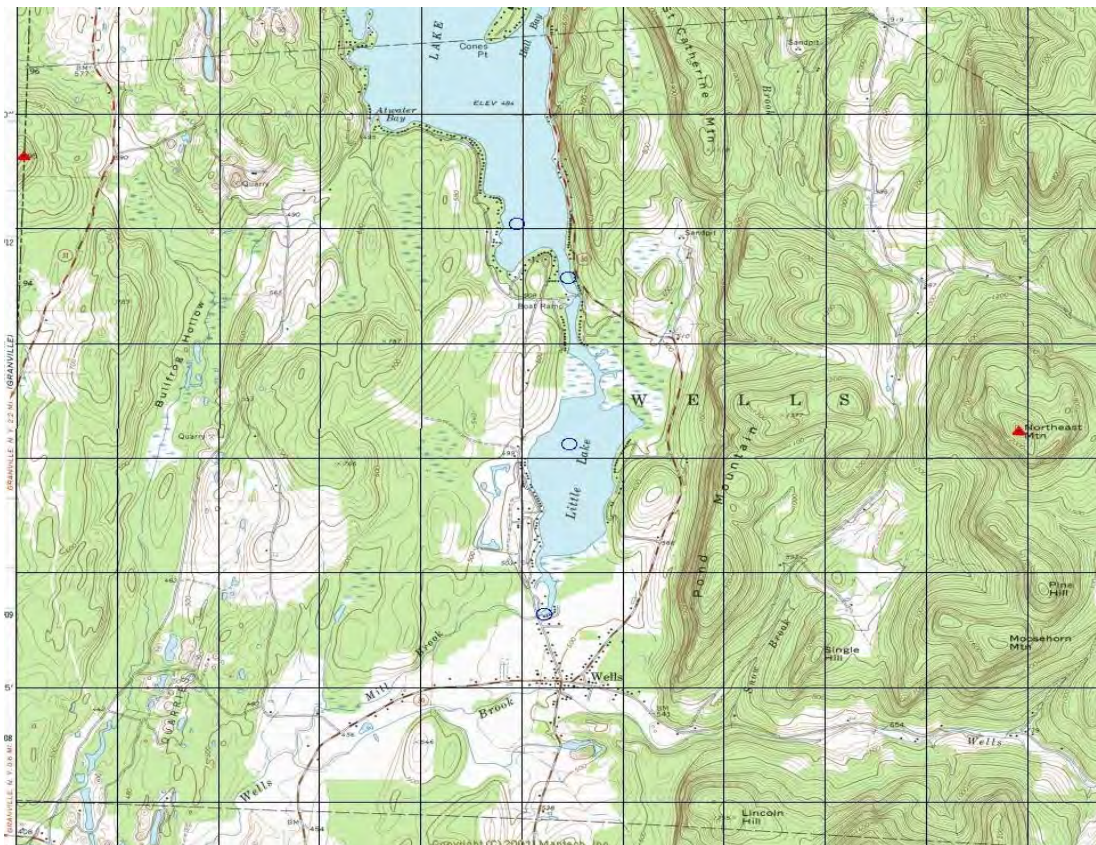
Attachment D - Sampling Site Locations (to be updated as needed)
Specific Sampling Locations for 2011

O denotes 9 Sample Sites (note 5 sites in upper map/4 sites in lower map)
