# LAKE ST CATHERINE AQUATIC VEGETATION MANAGEMENT PROGRAM 2015 ANNUAL REPORT

*December 2015*

Aquatic Control Technology  
11 John Road  
Sutton, MA 01590

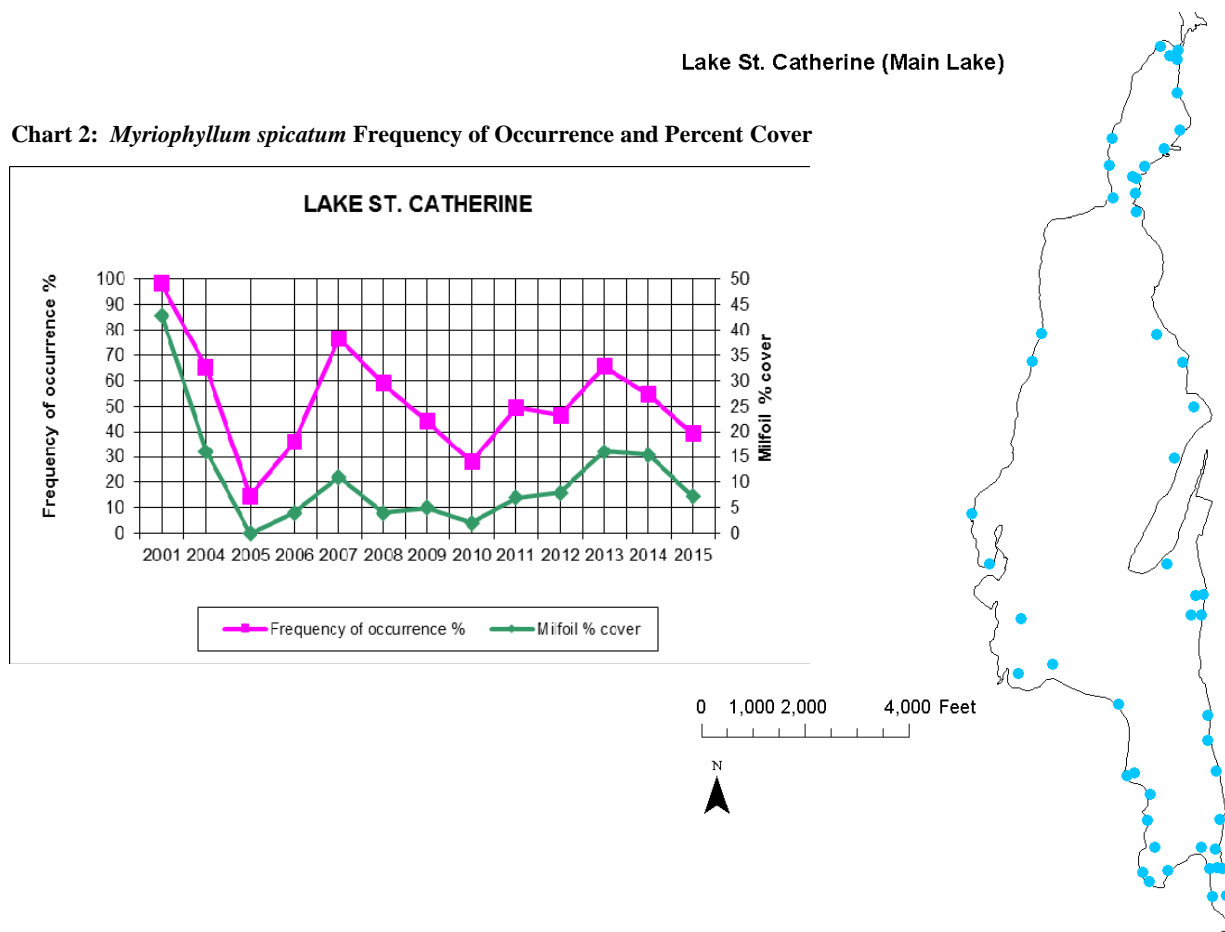
Chart 2 (below) represents year-to-year change in milfoil frequency and cover in the main basin.

Milfoil FOC decreased between 2014 and 2015 from 56% to 39%, due in large part to successful treatment of a few of the large dense beds of milfoil. Robbins Pondweed (*P. robbinsii*) was the dominant species at nearly 50% of the locations where found. Average cover of milfoil displayed a favorable reduction in the Main Lake from 2014 to 2015, decreasing from 15% to roughly 7%.

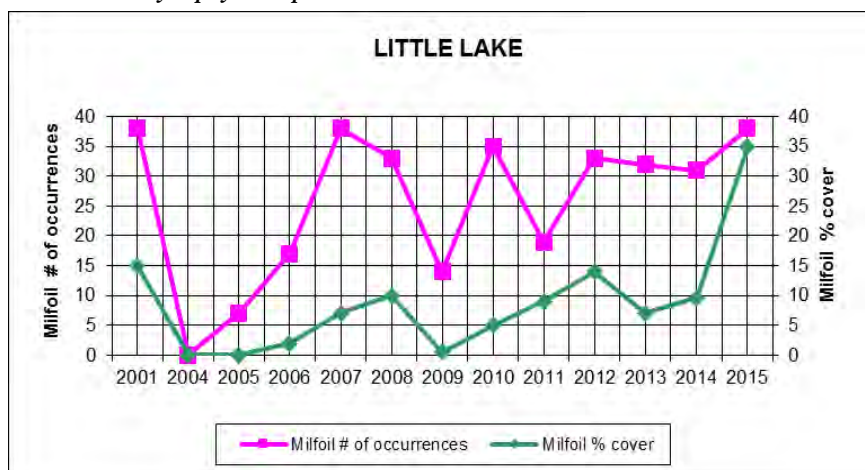
Chart 3: *Myriophyllum spicatum* Number of Occurrences and Percent Cover

*Potamogeton illinoensis* (71%), *M. spicatum* (86%), *Vallisneria americana* (50%), and *Potamogeton robbinsii* (73%) dominated the aquatic plant community in Little Lake accounting for a large percentage of the plant density recorded during the September 2015 survey. *Ceratophyllum demersum*, *Elodea canadensis*, and *Nymphaea odorata* remain common in Little Lake and were encountered at of the surveyed data points, 23%, 23% and 27%, respectively. *Myriophyllum spicatum* FOC remained high (86%) in Little Lake. Cover of milfoil was in erratic with scattered dense patches throughout the basin. Despite widespread distribution milfoil was only the dominant species at 6 of the 38 locations where documented, however, average milfoil density increased significantly in Little Lake from a 2014 average of roughly 10% to over 35% estimated cover in 2015.
