# LAKE ST. CATHERINE

Aquatic Vegetation Management Program

2018 Annual Report

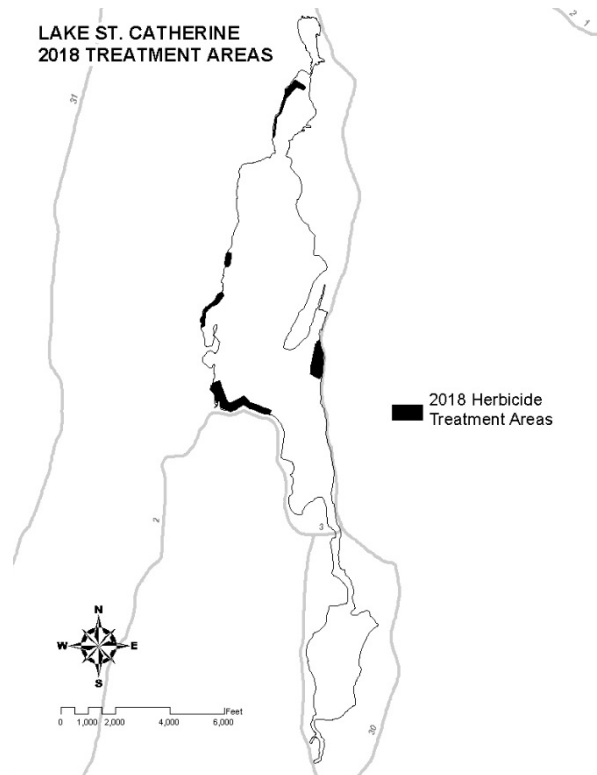
Figure 1. 2018 Treatment Areas

A total of 47.2 acres amongst five areas were targeted for treatment (Figure 1). Consistent with previous years, each treatment area was evaluated with regards to EWM cover/distribution as well as several other factors including: potential for increased EWM spread; potential for effective treatment; and the overall benefit of milfoil control with respect to the lake, lake residents and other potential users. A final treatment map was provided to VT DEC for review and approval prior to treatment.

The treatment was conducted with a 20-foot aluminum work skiff. The granular Renovate OTF herbicide was applied using back-mounted calibrated cyclone-spreader systems. The liquid Renovate 3 herbicide was injected at depth subsurface using weighted hoses that trailed the spray boat. An onboard GPS unit was used to provide real-time guidance and ensure an even application in each of the treated areas. The State Boat Ramp located on the channel between the Main Lake and Little Lake was used as the base of operations.

Treatment was performed as a split application whereby roughly 70% of the herbicide was applied to each of the designated areas initially and then the remaining 30% was applied several hours later. There was approximately 3-4 hours between each application. This split application approach has been used in recent years to increase concentration-exposure-time and help increase treatment efficacy. Both Renovate 3 (liquid) and Renovate OTF (granular) formulations of triclopyr herbicide were used at Lake St. Catherine in 2018. The granular formulation has proven to be effective for steeply sloped areas, smaller EWM beds and in areas where there is potential for excessive dilution from untreated water. The liquid formulation was used in larger treatment and cove areas that were not subject to as much dilution.

The application rate for Renovate OTF (granular) was 2.25 ppm in bottom 4-6 feet of water, or 240 lbs/ac. The liquid Renovate 3 was applied at 1.5 ppm, assuming a 6 foot average depth in most treatment areas. A total of 1968 pounds of Renovate OTF and 316.7 gallons of Renovate 3 were applied. The treatment took approximately 7 hours to complete.

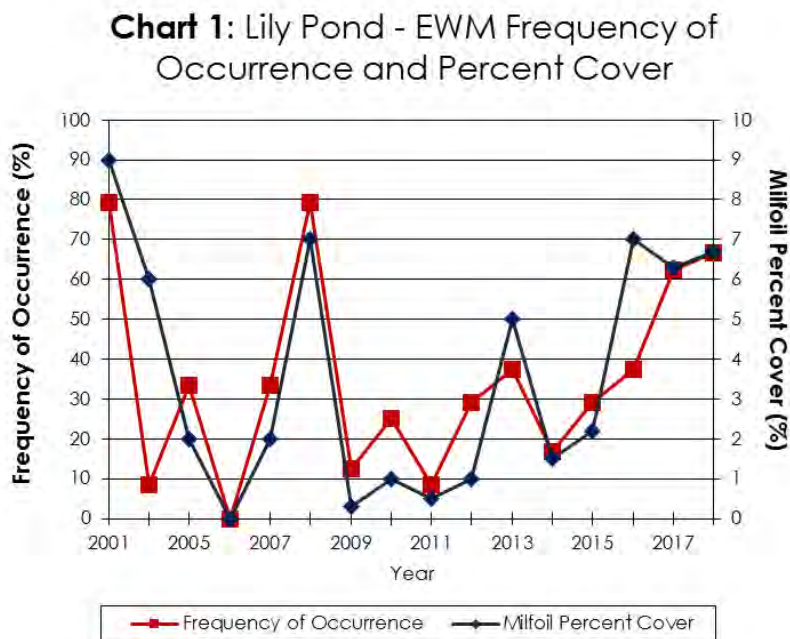
**Figure 2:** Lily Pond - Fall 2018 EWM distribution

Annual increases in EWM frequency of occurrence in Lily Pond have been observed, as treatment has not been conducted within this basin since 2014. There was only a slight increase in both EWM FOC and percent cover within Lily Pond since last year (Chart 1, Figure 2).

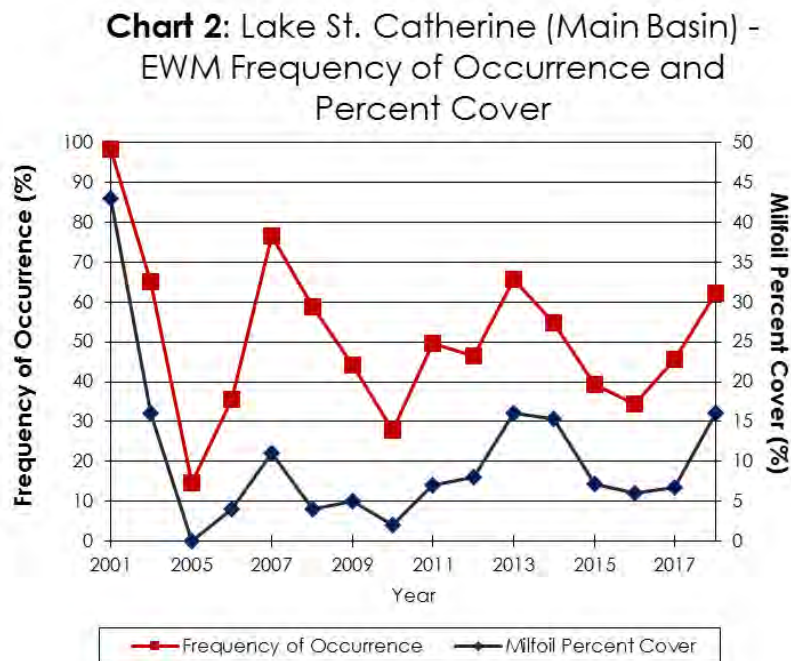
Chart 2 (below) illustrates the year-to-year change in EWM frequency of occurrence and percent cover in the Main Basin.

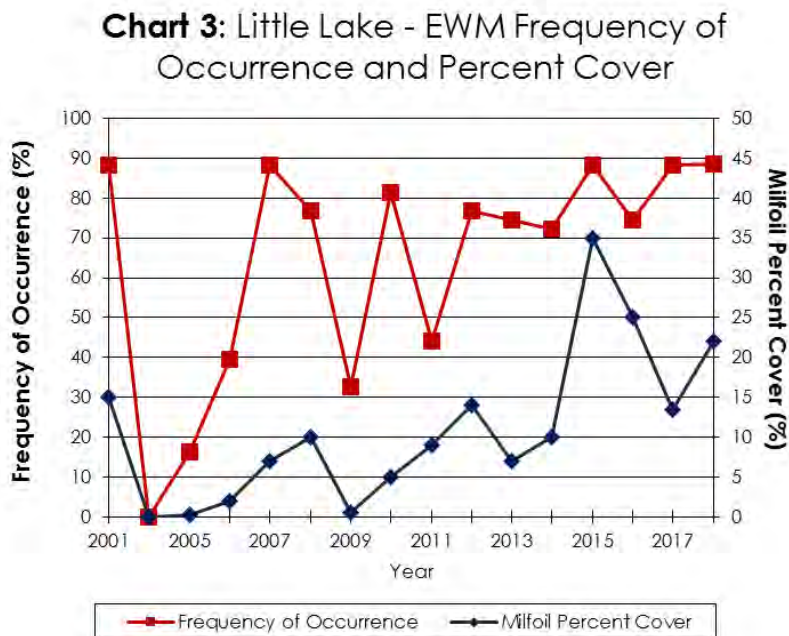
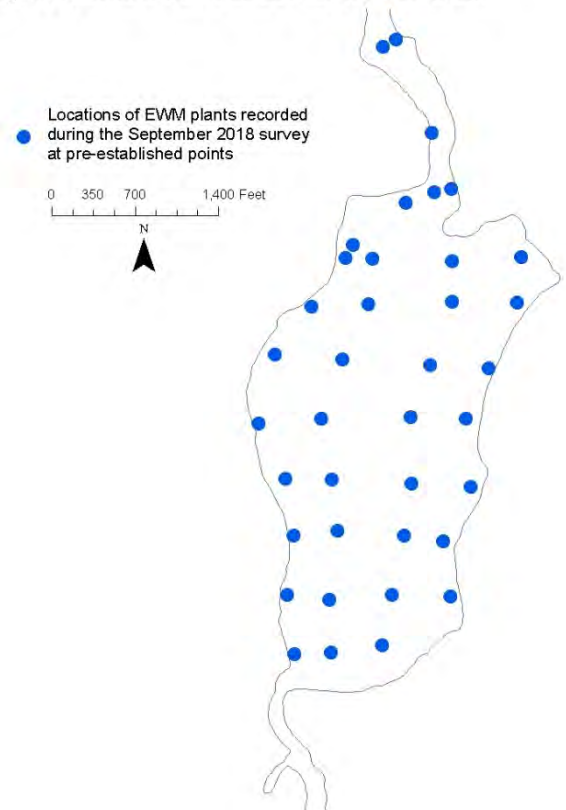
Figure 4: Little Lake - Fall 2018 EWM distribution

Overall plant cover within Little Lake saw a significant increase, from 49% in 2017 to 84% this year. Only nineteen (19) species were observed within this basin this year, compared to twenty-five (25) last year. Little Lake's consistent, shallow depth (6 foot average), allows for such a diverse plant community, but also allows for plant growth to dominate the entire water column, likely hindering recreational uses of the basin. Additionally, average species richness increased by ~1 species per point compared to 2017.

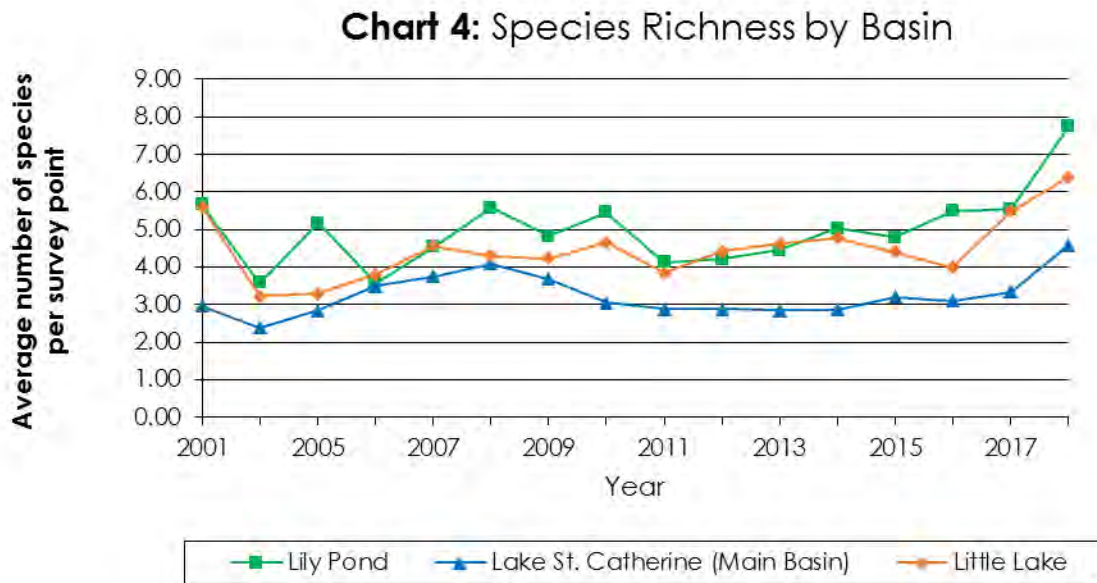
In all three basins, species richness increased compared to findings from past years with an overall average of approximately five and a half species per point (Table 2, Chart 4). Each basin's increase is likely related to the higher number of species and new species observed. Overall, species richness or native plant diversity in any of the basins does not appear to be impacted adversely by the herbicide spot-treatments or other EWM management activities.

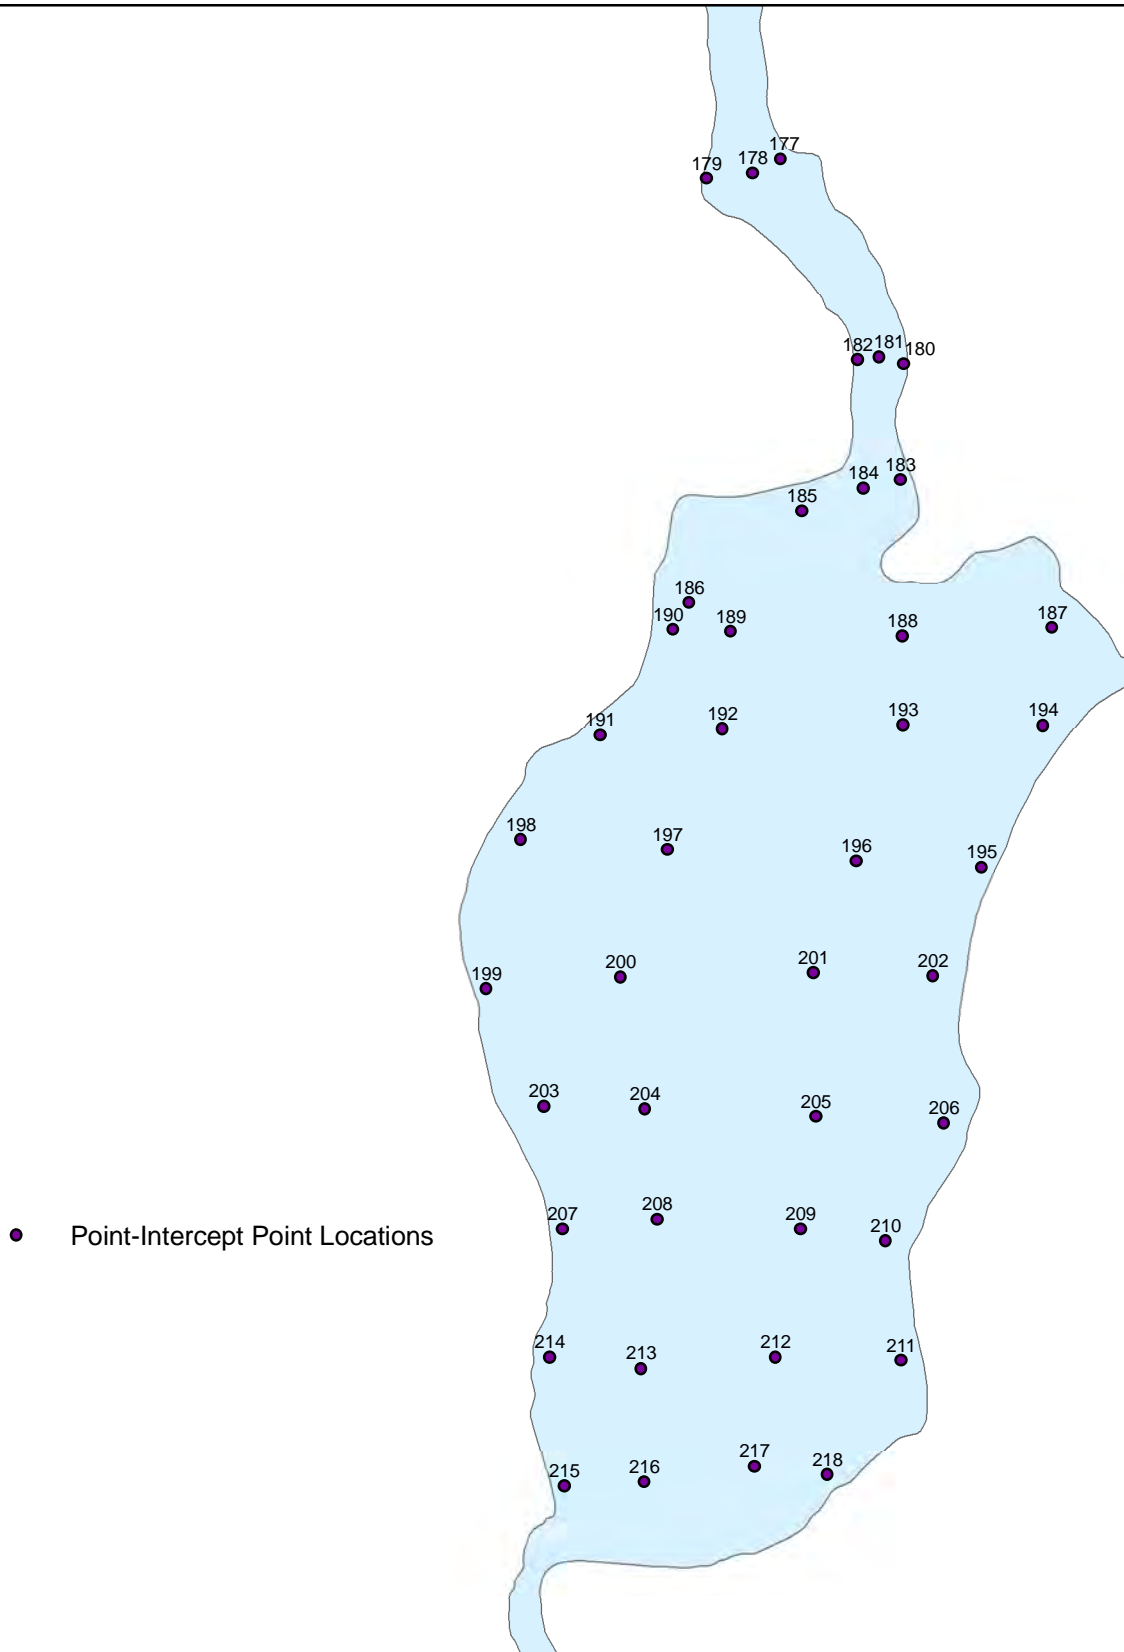
- 0 - No plant growth
- 1 - Very low plant growth
- 2 - Plant growth extending into water column
- 3 - Plant growth extending near surface
- 4 - Plant growth at surface

assigned at each data point to document the amount of plant growth vertically through the water column. Plant biomass was estimated on a scale of 0-4, as follows:

- 0 No biomass; plants generally absent
- 1 Low biomass; plants growing only as a low layer on the sediment
- 2 Moderate biomass; plants protruding well into the water column but generally not reaching the water surface
- 3 High biomass; plants filling enough of the water column and/or covering enough of the water surface to be considered a possible recreational nuisance or habitat impairment
- 4 Extremely high biomass; water column filled and/or surface completely covered, obvious nuisance conditions and habitat impairment severe

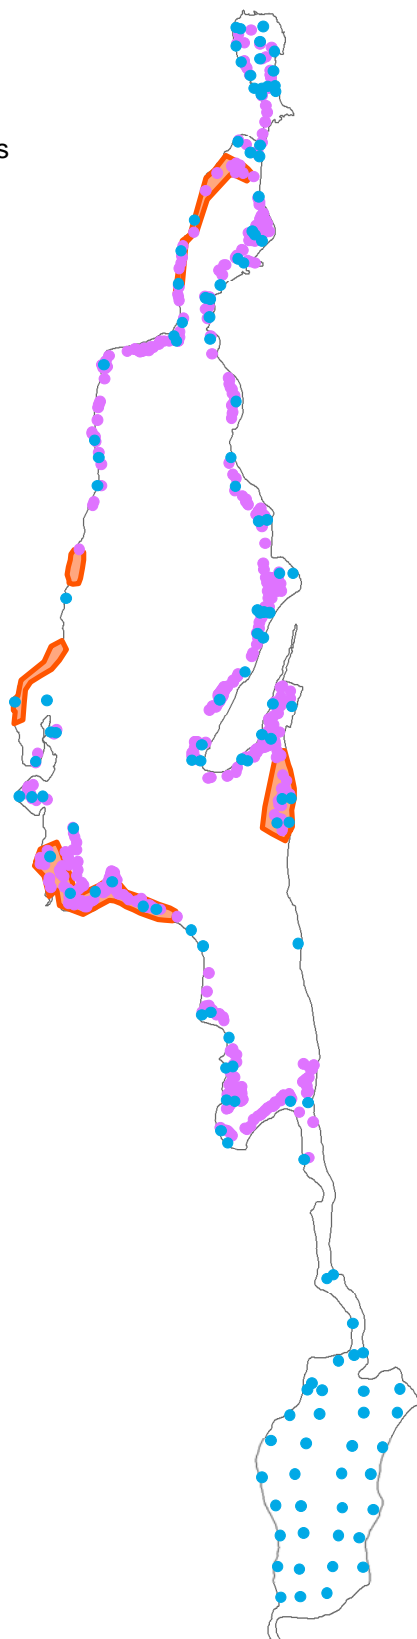
- Littoral zone EWM locations
- Pre-established point EWM locations
- 2018 Herbicide Treatment Areas
